# BURST PRESSURE FAILURE OF TITANIUM TANKS DAMAGED BY SECONDARY PLUMES FROM HYPERVELOCITY IMPACTS ON ALUMINUM SHIELDS

H. Nahra<sup>1</sup>, L. Ghosn<sup>1</sup>, E. Christiansen<sup>2</sup>, B.A. Davis<sup>2</sup>,  
C. Keddy<sup>3</sup>, K. Rodriguez<sup>3</sup>, J. Miller<sup>4</sup> and W. Bohl<sup>4</sup>

<sup>1</sup>NASA- Glenn Research Center, 21000 Brookpark Rd., Cleveland, OH 44135

*American Physical Society  
Shock Compression of Condensed Matter  
June 26-July 1, 2011  
Chicago, IL*

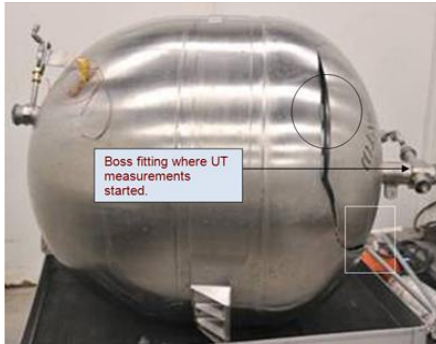
The two damaged tanks (#0062 and #0092) and a third undamaged tank #0251 were pressurized to burst at WSTF. As shown in Fig. 2, tank #0251 failed at the ellipsoidal ends opposite of the hemispherical end that was targeted in the HVI tests. Tank #0092 failed at the same ellipsoidal end as #0251. However, Fig. 3 shows that tank #0062 failed at the hemispherical end that was targeted and where excessive and unexpected damage occurred because of the late sabot separation. Moreover, the #0062 tank failed at significantly lower pressure of 580 psig compared to tank #0251 that failed at 795 psig and tank #0092 at 785 psig.

**Figure 2.** Tank #0251 failure at Ellipsoidal end. Tank #0092 exhibited the same failure.

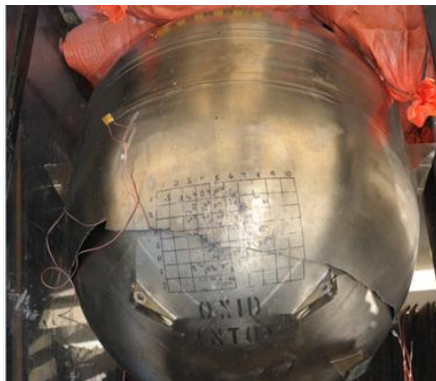
**Figure 3.** Tank #0062 failure at the damaged area.

From the pressure-time curve of tank #0062 and from a close examination of the crack line and a crater that exhibited spallation, it was suspected that the failure of tank #0062 was due to crack propagation rather than a material failure due to loss of strength under the applied pressure. Tanks #0251 and #0092 on the other hand failed at significantly higher pressure such that the ultimate strength of Titanium was exceeded. For instance, at a pressure of 795 psig, the shell theory predicts a stress of about 149 ksi which exceeds the titanium ultimate strength. This prompted the need for a linear fracture analysis to gauge the stress intensity factor and compare it to the titanium fracture toughness.

Since spall cracks were suspected of resulting in the observed 27% reduction in the burst pressure of the tank, the recommendation is to limit the allowable depth of penetration that does not result in back spallations. This recommendation needs to be more specific based on pressure wall thickness, material and impact conditions. Future work encompasses a thorough evaluation of the Ti material strength and detailed look at the crack line with diagnostics such as Scanning Electron Microscopy and elemental analyses in order to assess the evidence of the stable crack propagation prior to final failure

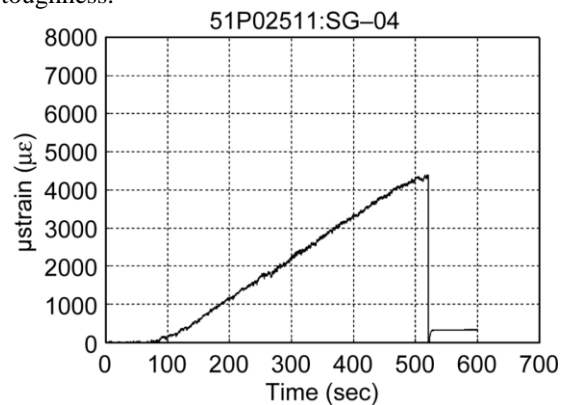
The strain versus time history of tank #0251 during pressurization and up to the failure is shown in Fig. 4, while Fig. 5 shows the same data

**Figure 4.** Strain-time curve for tank #0251.

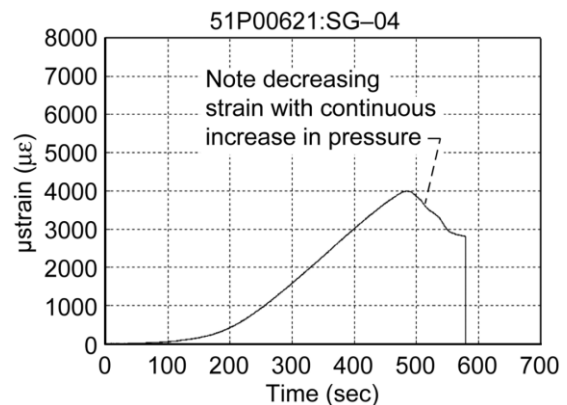
for tank #0062. From the strain-time history curve, it was apparent that the failure of tank #0062 was preceded by a time interval of declining strain which could be caused by a slow depressurization of the tank. At about 575 sec, an abrupt decline in strain was observed similar to tank #0251 at about ~520 sec. However for tank #0062, the interval between the peak strain and the abrupt decline in strain invited suggestions of slow damage progression (a stable crack growth process) before final failure.

**Figure 5.** Strain-time curve for tank #0062 that failed at the damaged area.

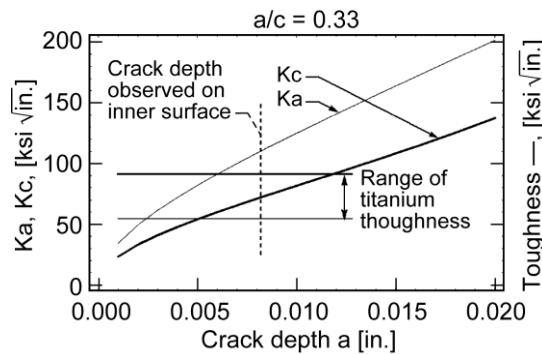
**Figure 6.** Calculated stress intensity factor and comparison with the Titanium toughness from literature.

For a crack depth of 0.0082", the stress intensity factor for crack depth-Ka exceeded the titanium toughness. This suggests that the failure may have been driven by fracture mechanics. The stress intensity factor for the crack length Kc for a crack depth of 0.0082" fell in the middle of the Ti toughness range. This range was reported because we have not measured the toughness of the titanium used in the tanks.

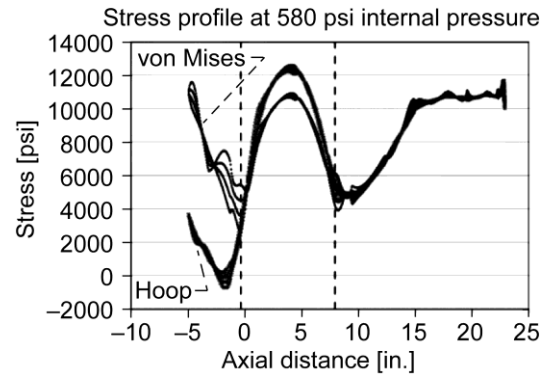
To further corroborate the argument, a finite element analysis (FEA) on the tank was performed. For a pressure of 580 psi, the FEA showed in Fig. 7 that the Von-Mises stresses/criterion was below the yield limit of Ti-6Al-4V, yet the calculated stresses from the shell theory showed yield and ultimate strength exceedance at the higher burst pressures of tanks #0092 and #0125.

**Figure 7.** Finite Element Analysis of Ti tank at 580 psig.

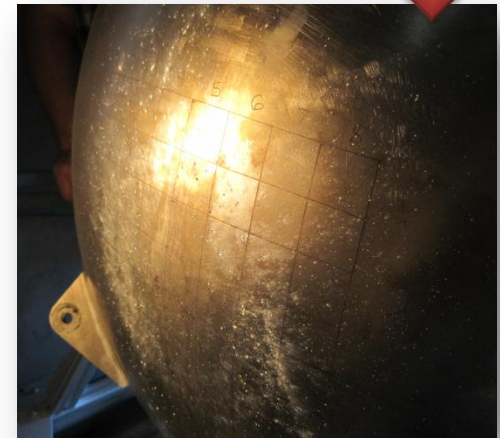
0062 Tank

- Damage Distribution of Tank 0062 caused by 1.6 mm Al projectile and Sabot pieces
  - Exhibits two areas of damage which may have been caused by the sabot piece impacting the Al shield
  - Distribution exhibited deeper than expected impacts
- Damage Distribution of Tank 0092 caused by 3.6 mm Nylon projectile
  - Exhibited Uniform damage distribution as seen in stressed and unstressed coupon HVI tests

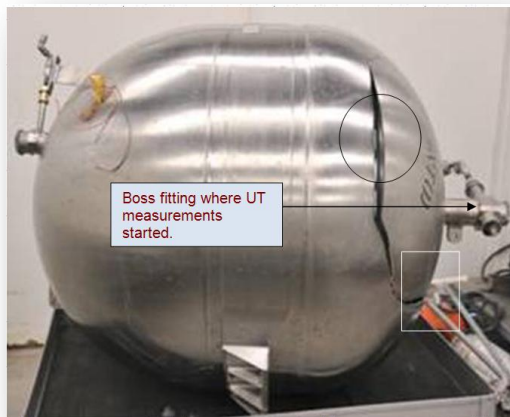
A-Tanks P0251 P0092 failed at Elliptic end

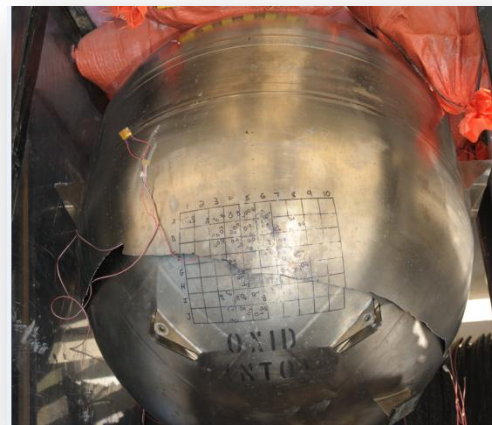
B-Tank with crack shown in the impacted area

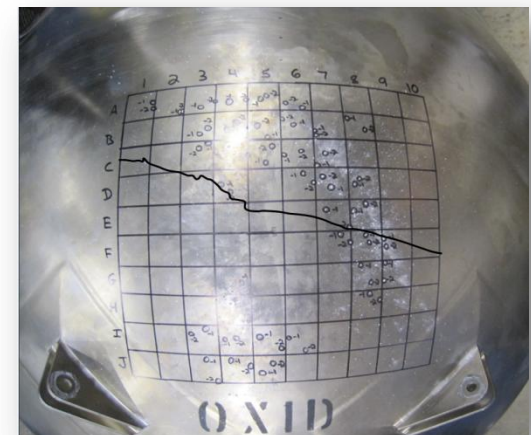
C-Crack line superimposed on tank

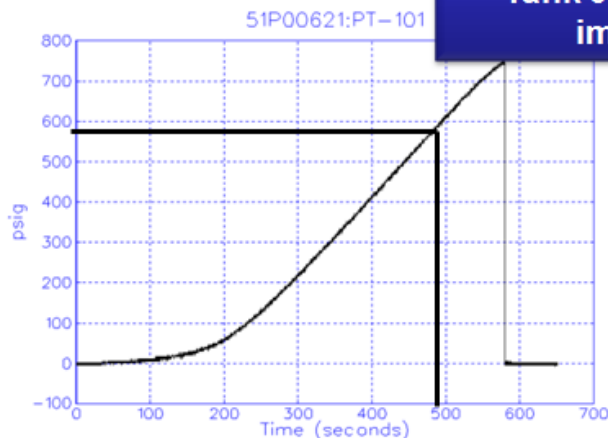
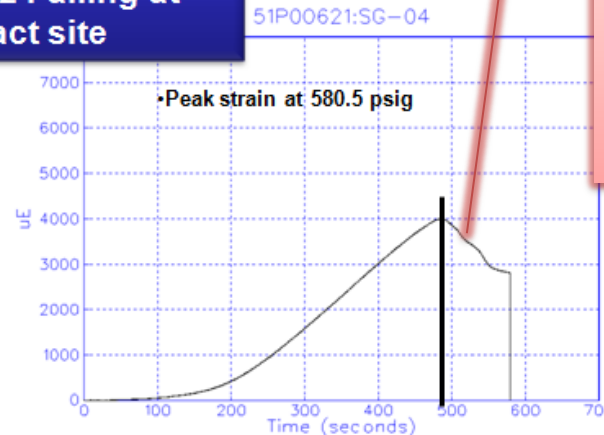
**Tank 0062 Failing at impact site**

Decrease in strain eluding to a relief process followed by the tank failure. **Note the difference with tank 251**

Failure of Tank 0062 could have been induced by a crack propagation
